1. STATE Maryland COUNTY Cecil

PRESENT USE Ruins WALL CONSTRUCTION Squared log grooved construction

HISTORIC AMERICAN BUILDINGS SURVEY INVENTORY CE - 36

Condition: RUINS

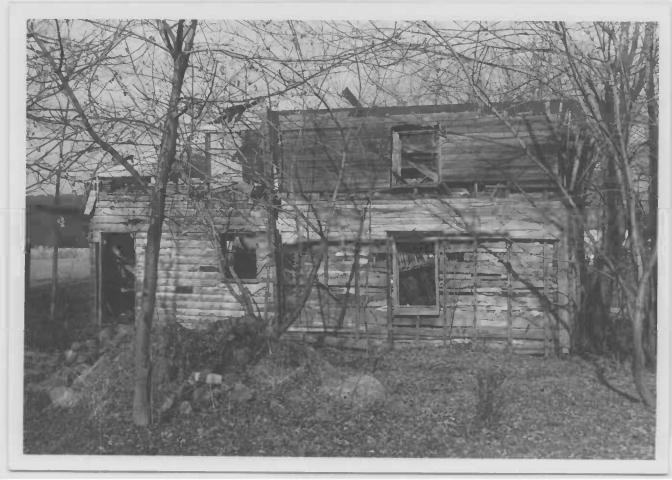
CECIL CTY # 36 (G.36 39 DG 12/67

This was a small log building two bayssquare and two stories in height which probably had an A-roof. (The roof is now completely gone.) This log dwelling was built into a slightly larger frame structure. The logs are square and laid in a grooved construction pattern, one on top of another. Many adze marks show on their surfaces. They are chinked between with plaster and fragments of broken brick.

This structure is important even in its ruinous state as ome of the few surviving log structures in this county. Its site should be noted since it seems to be beyond repair. It is also interesting because it is two stories in height even though it is such a tiny structure.

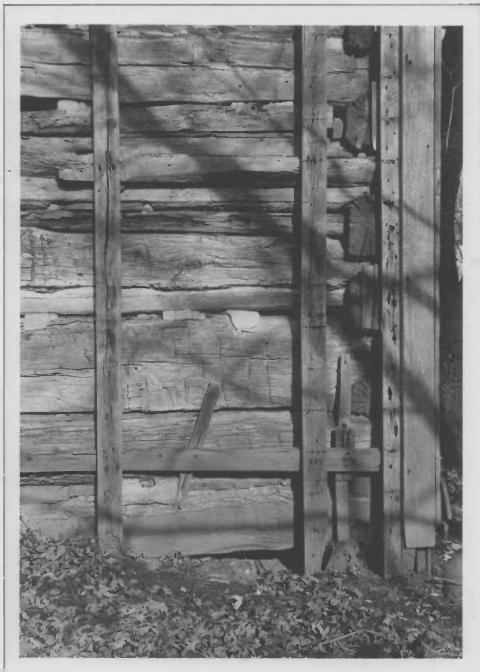
Ruined Log House Oakwood Cornering Detail
